the Watershed Watch

Newsletter of Salt Lake County Watershed Planning & Restoration

Spring 2018, Issue 18

Assessing stream health by evaluating stream channel stability

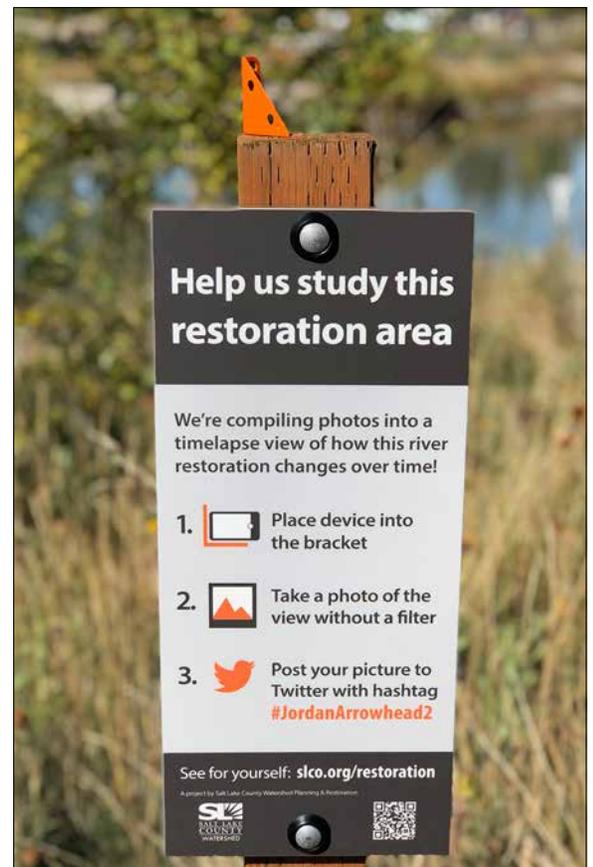
Salt Lake County Watershed is crowdsourcing photos to help monitor change at our stream restoration projects along the Jordan River.

Salt Lake County Watershed Planning & Restoration is using crowdsourced photos to help with the ongoing monitoring of our stream restoration projects on the Jordan River! “How?” you may ask. It’s simple: Put up a sign inviting people to set their phone or camera in an angle bracket, take a photo, and post it to Twitter with a site-specific hashtag. Then harvest the photos to create slideshows that show change over time.

Jordan River Trail users may have already noticed a number of these “self-serve” photo monitoring stations, which were installed last fall. What’s new are the crowdsourced slideshows, now available on our website at <http://slco.org/watershed/restoration/monitor-change>.

Post-project monitoring is an important part of any restoration project. With the new photo stations, we’re inviting citizens to become part of the monitoring process. This is truly a crowdsourcing effort. Salt Lake County doesn’t own these photos. We won’t download and save the photos. Instead, we developed an online tool that harvests the Twitter hashtags and allows us to view the photos in a slideshow format. Image consistency is important for photo monitoring to be effective. The bracket on top of each photo station helps to ensure a consistent height, angle, and direction for each

photo. It’s not perfect. Some photos have been taken vertically, when ideally we prefer them horizontal to capture as much of the restored streambanks as possible. But that little glitch aside, we’re getting loads of great photos! The end result: slideshows that simulate timelapse photography.

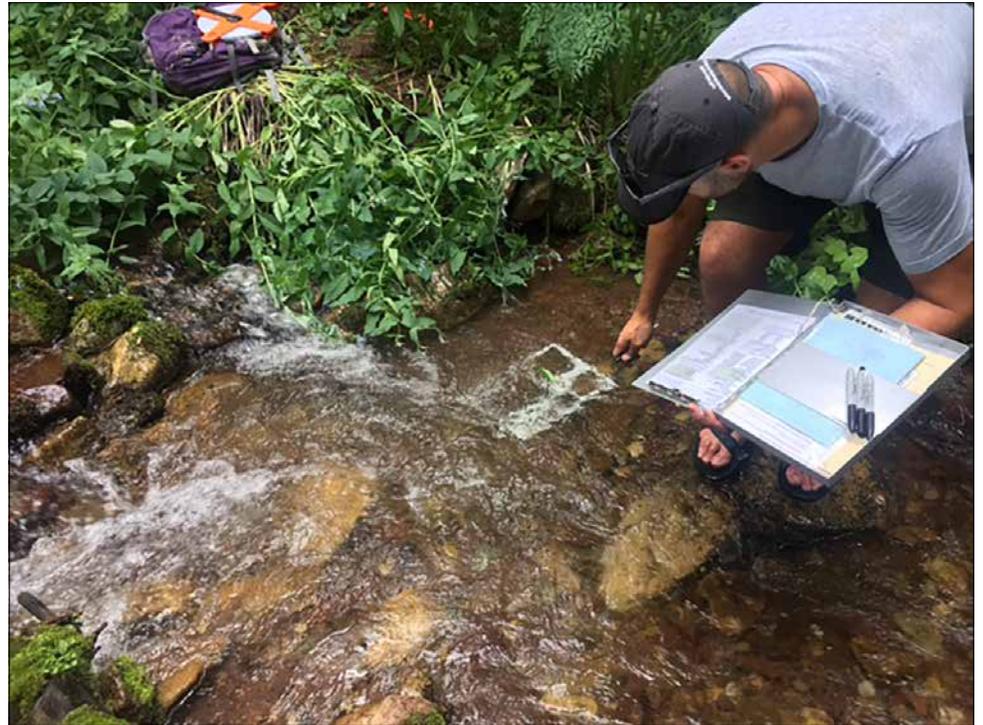
A device called a "gravelometer" (shown in the water) is used to measure the size of sediments (pebbles, cobbles, etc.) found in the stream banks and bed. This is one of many data variables collected by the Watershed Program to assess stream channel stability.

To evaluate channel stability, Watershed Program staff walk each stream to first delineate them into units called **reaches**, which are defined based on changes in geology and tributary influences. A variety of data is then collected for each reach using the Pfankuch Method (pronounced "fahn-cook"), which provides a combined assessment of physical variables of the upper bank, lower bank, and stream bed. Each variable is assigned a score, some weighted based on level of importance, and a final combined score indicates whether the overall channel stability is "Good", "Fair", or "Poor", based on stream type.

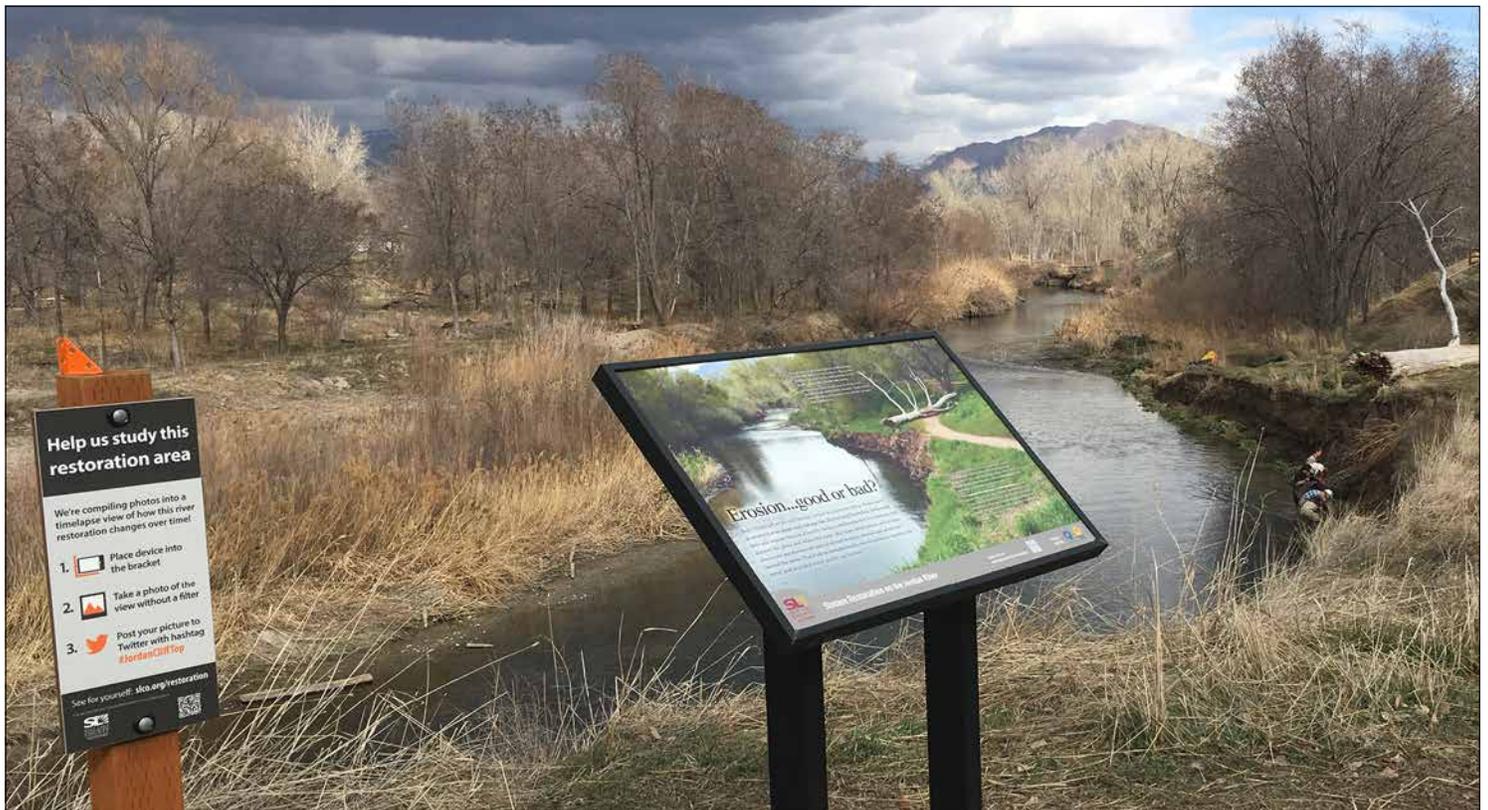
Located at approximately 5100 S on the Murray side of the river, photos taken at this “self-serve” photo monitoring station will document change on the eroding streambank shown on the right. Look closely and you can see Watershed Program staff in the water! We were installing a bank stabilization technique in February 2018, to help slow down the rate of active erosion.

Next time you're on the Jordan River Trail, keep an eye out for the photo monitoring stations. And snap a few pictures! Five photo stations along the stretch of river from Arrowhead Park at 4800 South to approximately 5100 South in Murray, are documenting the Watershed Program's restoration work begun in 2015. One at Winchester Park (6500 South in Murray) is documenting the channel repair and revegetated streambanks completed in 2015. In Draper, one photo station was installed at our river realignment project at 12600 South (near Jordan River Rotary Park), which was completed in 2010.
